ACCIDENT ANALYSIS

Superior Offshore International Project on BP Marlin Platform

DIVING SAFETY ALERT

Diver Injury using Cavitation Blaster

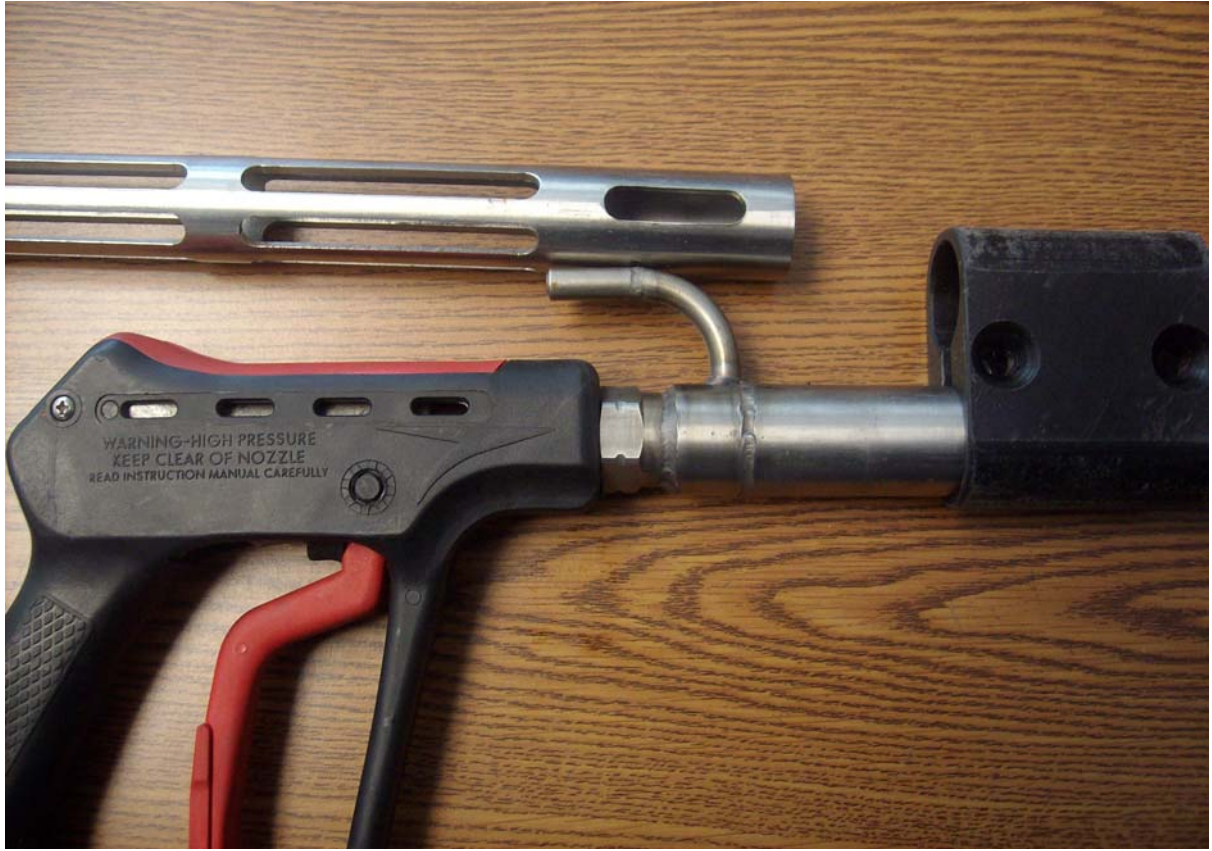
Figure 1

CaviDyne has redesigned the guard so that it cannot slip. This will eliminate the scenario that appears to have been encountered in this instance where the guard was initially at a safe length but, after use, slipped and exposed the operator's arm to high water velocities near the tip of the nozzle. The redesign incorporates a slot in the guard through which the reverse-thrust nozzle is inserted (Figure 1). This prevents the guard from slipping in the event that the black polycarbonate clamp becomes loose.

In order to maintain the effectiveness of the nozzle, the ambient water velocity inside of the guard must be minimized. Because CaviDyne has moved the nozzle away from the end of the guard, longer slots (Figures 1 and 2) are machined into the revised guard. These longer slots will inhibit the ambient water inside of the guard from obtaining significant velocity in the direction of the water jet and will maintain the effectiveness of the reverse-thrust jet.

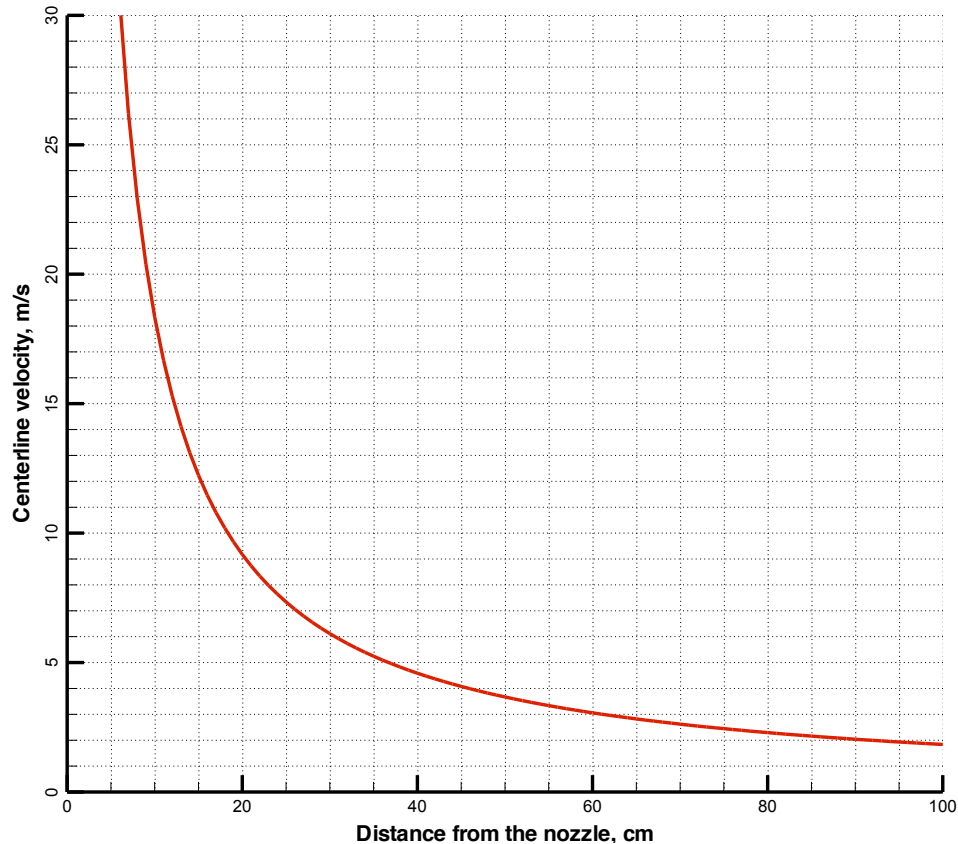
Figure 2 - Changes in jet centerline velocity with distance from the nozzle

As illustrated by Figure 2, the centerline velocity of the jet rapidly decreases with distance from the nozzle. While the exit velocity of the jet was calculated to be at almost 180 m/s it slows down to about 5.5 m/s after traveling 30 cm.

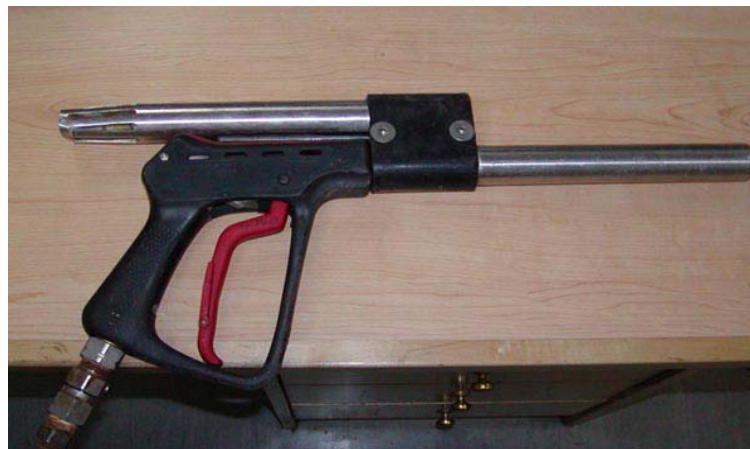
Photos 1-3 in the Diving Safety Alert (Attachment 2) show that the end of the guard had been crushed prior to the accident. Photo 2 also shows that the guard was broken and part of the guard was missing. It is likely that this was at least one cause of the guard slippage and was a possible additional factor in the injury. CaviDyne has increased the wall thickness of the stainless steel guard to 3.2 mm (1/8”) (Figure 2). This will make it more difficult to damage or deform the guard as well as compensate for the strength lost by lengthening the slots.

Photo 1 – Cavitation gun

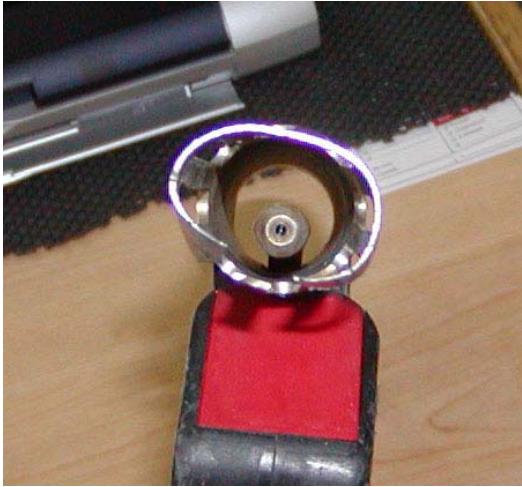
Photo 2 – End view of retro-jet

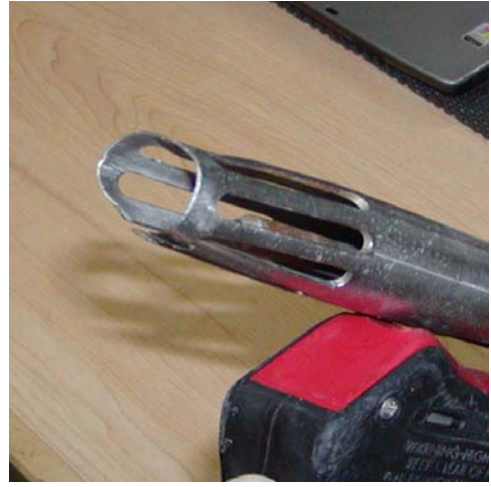
Original engineering of the retro-jet did not prevent diver injury, due to the end of the rear baffle being less than two inches from the retro-jet. During the HAZID and following Risk Assessment of the gun and system, the retro-jet was not identified as having a high pressure injection risk as was the front jet.

Photo 3 – Side view of retro-jet showing proximity of retro-jet nozzle to end of baffle. (approx 3 cm)

Subsequent Actions: Manufacturer has modified the retro-jet by moving the nozzle further back inside the rear baffle. The incident report has been circulated within the company and this public notice is developed for distribution to the general public.

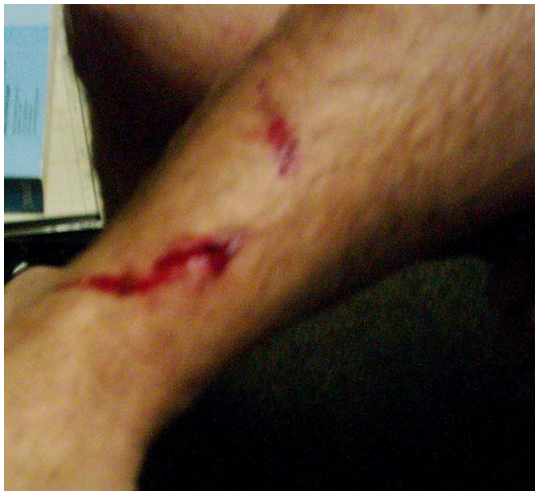
Photo 4 – High pressure injection injury to the diver's forearm
