# DIVING SAFETY ALERT

## May 2007

### Diver Injury using Cavitation Blaster

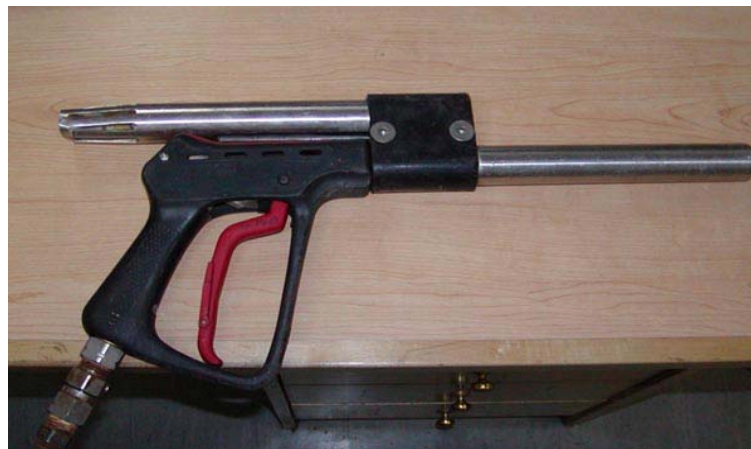
Photo 1 – Cavitation gun

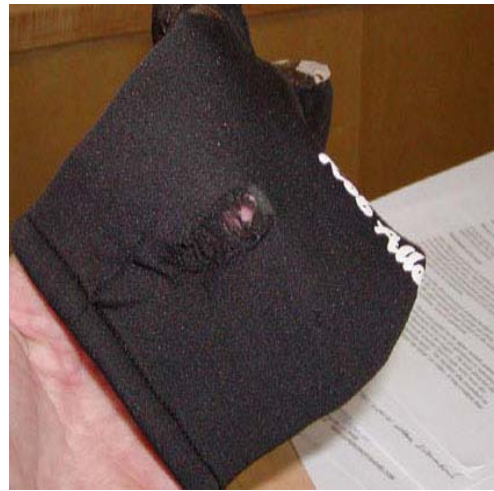
One thing that was discovered is that the diver was wearing protection that covered that area of his body but was not the 11" butyl rubber gloves recommended in the diving contractor procedures. As can be seen in photo 5 the retro-jet punched a hole through the neoprene glove, which may not have happened wearing butyl rubber gloves. But this is not a tested theory.

**Photo 5 – Diver's glove showing hole at location of injection**
