Bulletin No: DSN-HSEQ-S99-08-0001  
Date: 10.03.2008  
Issued by: DSN-HSEQ

## SAFETY BULLETIN

**Subject: Fatal Accident Onboard – MV "GEOSUND" in connection with the operation of the A-frame based LARS system with AHC**

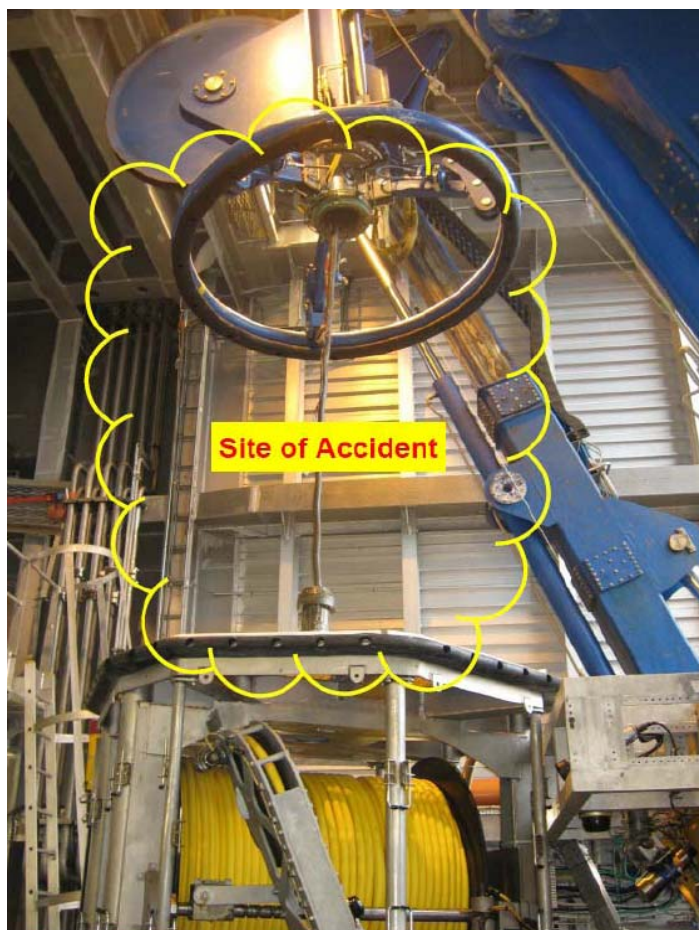
Prior to the incident, the ROV had been separated from the TMS and both units were resting on the base platform in the hangar, with the TMS located just underneath the Docking Head which was situated 2,5 m above the top of the TMS. The ROV was located adjacent to the TMS towards the port side of the hangar.

Around 10.30 hrs. a total power black out occurred onboard the vessel due to lack of cooling water supply to the auxiliary engines. The fatality happened at the time of the black out when the TMS unit made a sudden and significant vertical movement (approximately 2,5 m) until it was stopped by the Docking Head overhead. The ROV Senior Supervisor was standing on top of the TMS with the aim to assist with the pull-out of the umbilical. He was trapped and subjected to a massive force of 13,7 TE between the TMS and the Docking Head.

The accident occurred at the same time as the power black out. The ROV winch spooled in the umbilical instantly and uncontrolled, lifting the TMS module vertically up towards the Docking Head, causing the fatality.

The ROV Supervisor was standing on top of the TMS with the aim to assist the pull-out of the umbilical of which c.a. 5m had been slacked off when the incident occurred. He was trapped and his body exposed to a massive force of 13,7 Te between the TMS and the Docking Head.
