## IMCA Safety Flash 10/08

June 2008

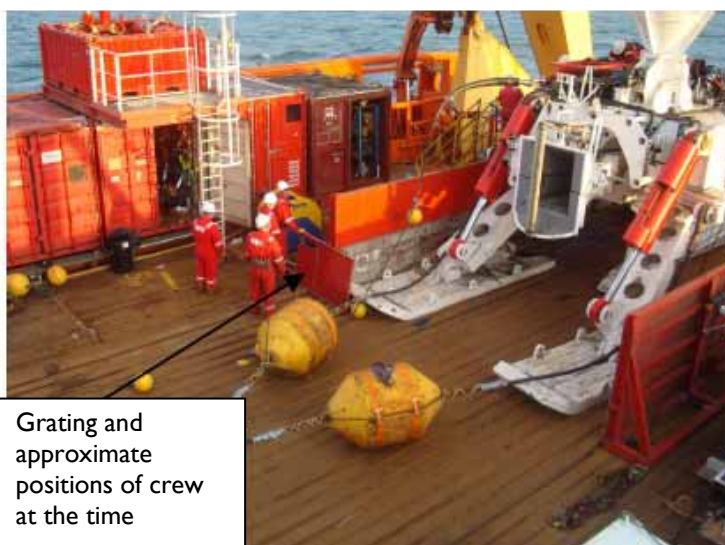
Whilst passing between the tigger and the plough guard the grating was disturbed and fell, striking the foot of the injured party. The grating was fitted with fixing lugs, one of which severely impacted the foot, penetrating the safety boot and caused the injuries.

Grating and approximate positions of crew at the time

- ◆ The grating was an obvious obstruction and partly blocked a frequently used access route to storage and working areas;
- ◆ It was left completely unsecured and incorrectly stowed;
- ◆ Three people attempted to walk round the obstruction without identifying the potential hazard – the fourth became the injured party;
- ◆ An obvious hazard went unchecked and subsequently caused an accident.

This incident occurred during routine deck activities when the level of hazard awareness and attention to detail was perhaps not as high as it would be when the vessel was fully operational on project construction work. This highlights the need for the same level of awareness, attention to detail and communications during routine work as there is during project construction operations.

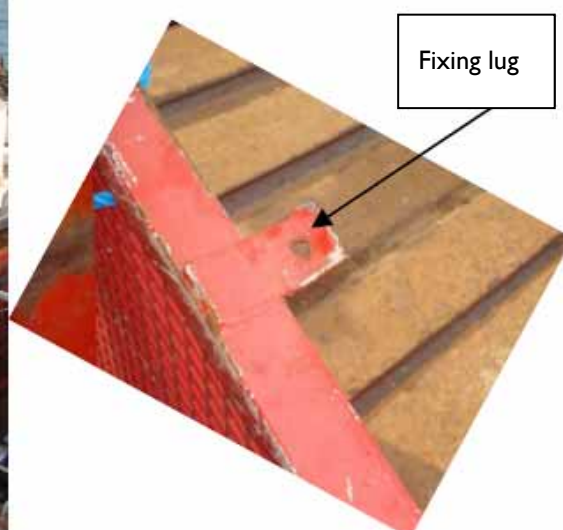
Fixing lug

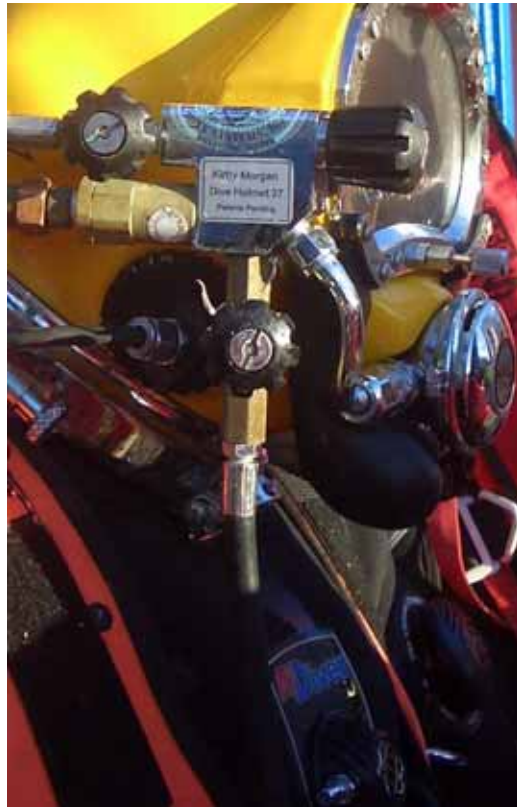
The practice of installing a dry suit inflation whip with modified fittings onto a KM 37 side block has been reported to IMCA.

- ◆ The modification to the side block assembly of the KM 37, shown in the photograph above, is not recommended;
- ◆ The leverage on the brass fitting is extremely high giving a high potential for breakage;
- ◆ The fitting at the bottom of the side block is a 3/8" straight thread fitting with an O-ring seal which is not designed to sustain this kind of leverage.

Members are reminded that an in-line valve is not deemed necessary by the helmet manufacturer, as long as a good quality and suitably approved inflator hose is used or the KMDSI restrictor adapter PN# 555-210.
