# Kirby Morgan Dive Systems, Inc.®

## Safety Bulletin #1 of 2007. March 1, 2007 Helmet Shell Repair Caution

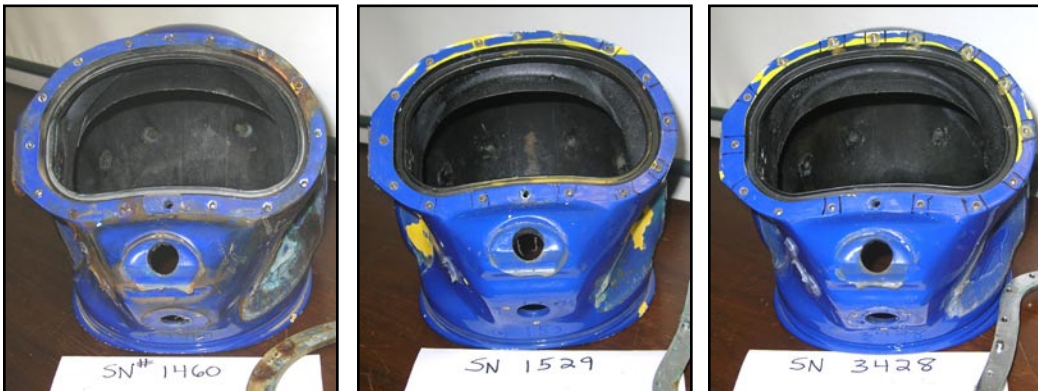
A visual inspection inside of all three helmets showed an obvious irregular finish around the regulator mount area. Once the paint was removed around the irregular area it was noticed that the whole lower section of the helmet had been previously removed and replaced with non-laminate filler.

*This is how the three stripped helmets appeared when they were received by the repair facility.*

These three helmets may not be the only ones that have been modified in this potentially dangerous way. Anyone noticing an irregular finish on the inside around the regulator mount as shown in the pictures, should not use the helmet and should immediately contact a KMDSI dealer or KMDSI. The helmets in question all came from the UK, however because of the international nature of commercial diving all users should use caution and carefully check any previously acquired used helmets.

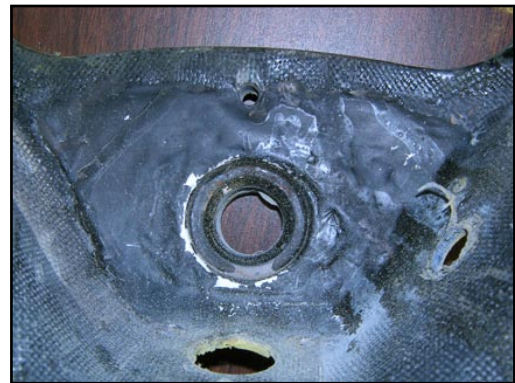
*The interior of one of the painted helmets shows obvious sub-standard repair work.*

Often Kirby Morgan helmets are painted by persons with good intentions, but who do not understand that when it comes time to replace an insert or repair fiberglass damage, all of the paint must be removed. This removal requires sanding, because chemical strippers will de-laminate the fiberglass. Sanding alone usually requires at least 2-3 hours work, thus greatly increasing the repair cost.

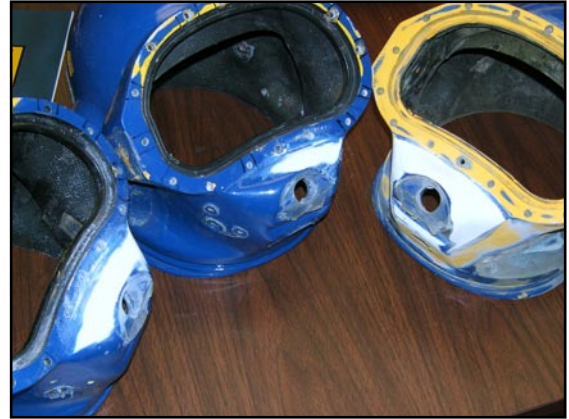
*The unauthorized paint job on these helmets concealed repairs performed with sub-standard materials.*

KMDSI has always discouraged painting of fiberglass helmets because there is no way of telling what lies beneath the finish. Refinishing should only be done by a specifically trained and certified KMDSI fiberglass technician. All repairs should be well documented, including pictures. Certified KMDSI fiberglass repair technicians will only use polyester gel-cote for refinishing and will only perform fiberglass repairs on helmets that have a record of repair, or only after removing any unauthorized coatings and performing a proper inspection.
