## THIS MIGHT HAPPEN

### Incident Description:

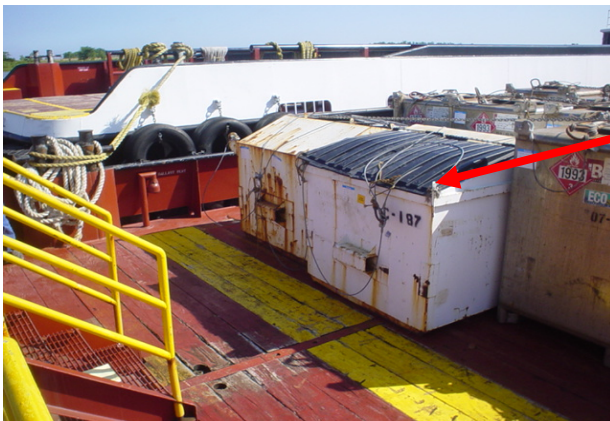
Four personnel were being transferred on a personnel basket from a Lift Boat to a supply vessel. As the personnel basket was lowered to the deck of the supply vessel, the personnel basket struck the top of a trash bin (as noted in picture below). This caused the basket to tilt resulting in 2 personnel losing their footing, releasing their hand hold and dropping 2-3 feet to the deck of the supply vessel. One of the personnel was not injured and the other suffered a broken ankle from the fall. The crane operator and the rigger repositioned the basket and the remaining 2 personnel were lowered safely to the deck.

Personnel basket landed on this trash bin

- Limited area to position and land the personnel basket on the supply vessel. The personnel basket measures approximately 6 feet in diameter and the available space was approximately 8 feet wide. The seas were running approx 3-5 feet and the winds were 20 mph and the available space was not large enough to land the basket with the vessel dropping into a swell.

- A JSA was not completed for the transfer of personnel and equipment.
- Deckhand put both hands on the personnel basket to guide the basket and the crane operator did not have any signals and continued to lower the load.

- Communication between the vessel and crane operator must occur prior to the lift to identify potential hazards and to ensure there are enough personnel (deckhands/riggers) and space available to perform the lift and landing safely.
